Property Inspection Report

Property address: **123 Smith Street, Anytown Ontario**

Inspection date: **Saturday, September 25, 2021**

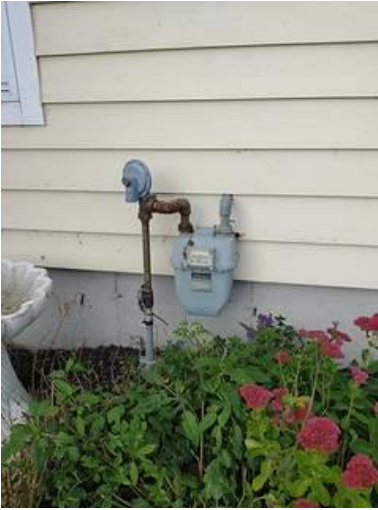
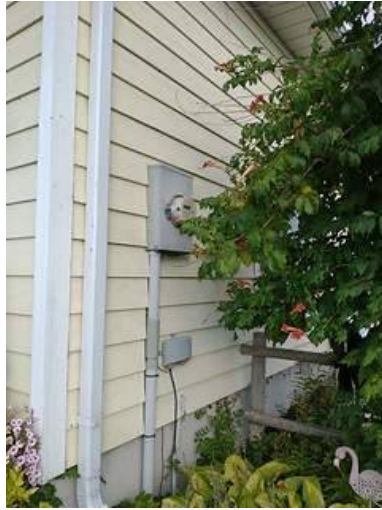
Vegetation was overgrown around equipment for one or more utilities such as gas or electric meters. Vegetation should be pruned or removed as necessary to allow unobstructed access.

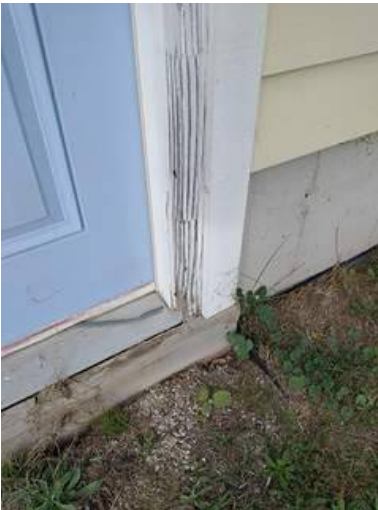
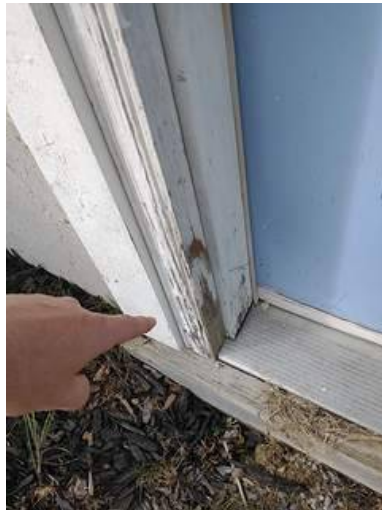
Some sections of siding and/or trim were deteriorated. Recommend that a qualified person repair, replace or install siding or trim as necessary.

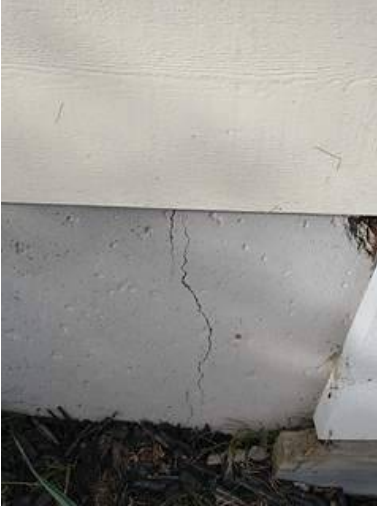
Photo 3-1

One or more minor cracks (1/8 inch or less) were found in the foundation. These didn't appear to be a structural concern, but recommend sealing them to prevent water infiltration and monitor them in the future. Numerous products exist to seal such cracks including hydraulic cement, non-shrinking grout, resilient caulks and epoxy sealants.

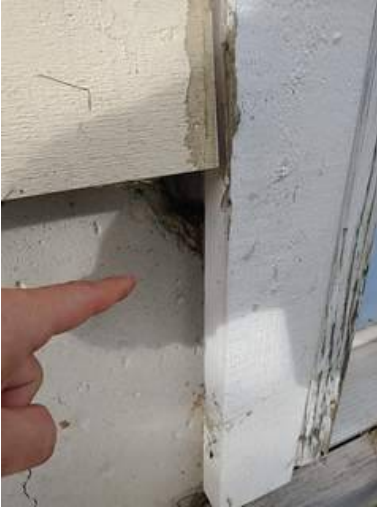
Photo 4-1

- 4) 🐭 One or more holes or gaps were found in or below the foundation. Vermin may enter the building substructure as a result. Recommend that a qualified person repair as necessary.

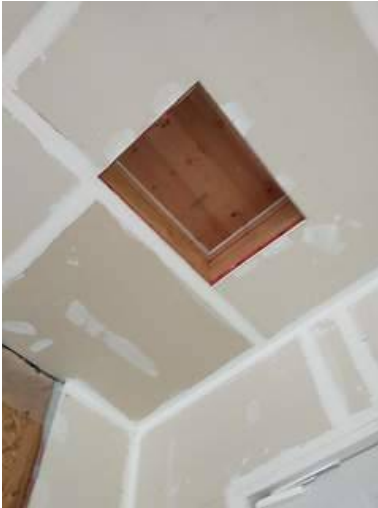
Photo 6-1

The attic access hatch cover in the attached garage ceiling was substandard. Current standard building practices call for wooden-framed ceilings and walls that divide the house and garage to provide limited fire-resistance rating to prevent the spread of fire from the garage to the house. This includes having an access hatch cover installed that is in good condition, with similar fire-resistance. Recommend that a qualified person replace or repair hatch cover(s) per standard building practices. For more information, visit:

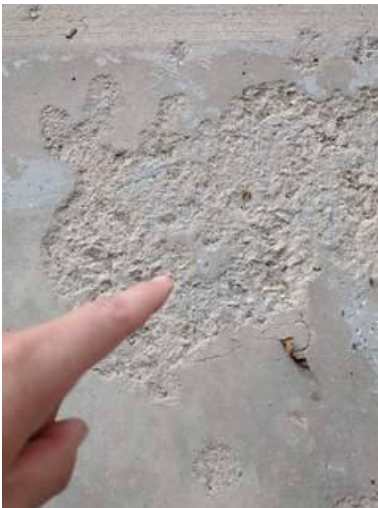
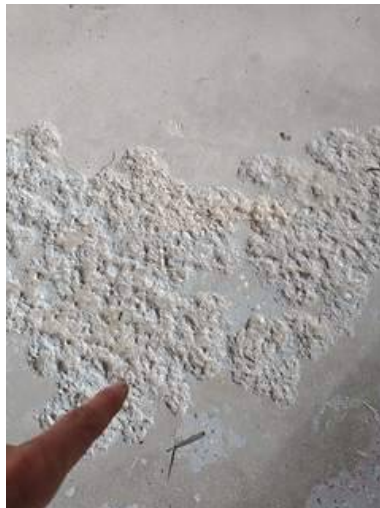
Minor cracks were found in the concrete slab floor. These are common and appeared to be only a cosmetic issue.

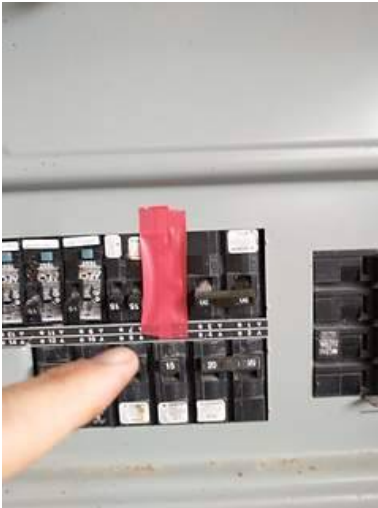
Photo 8-1

One or more slots where circuit breakers are normally installed were open in panel(s) #A. Energized equipment was exposed and is a shock hazard. Recommend that a qualified person install closure covers where missing.

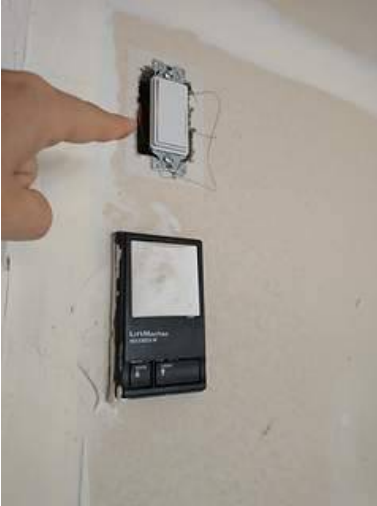
Photo 9-1

One or more cover plates for switches, receptacles or junction boxes were missing or broken. These plates are intended to contain fire and prevent electric shock from occurring due to exposed wires. Recommend that a qualified person install cover plates where necessary.

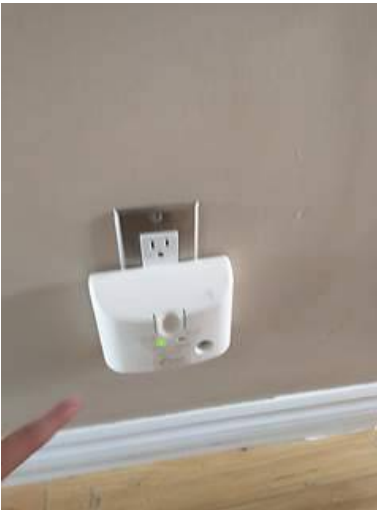
Photo 11-1

One or more "plug-in" type carbon monoxide alarms were found. Because such CO alarms can be easily removed, recommend that home buyers verify that CO alarms haven't been removed upon taking occupancy. If removed, then recommend installing new CO alarms in the vicinity of sleeping areas and on each level. Note that some states and/or municipalities require CO alarms to be installed for new construction and/or for homes being sold. For more information, visit:

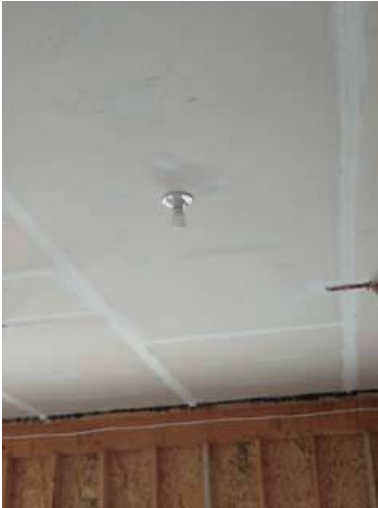
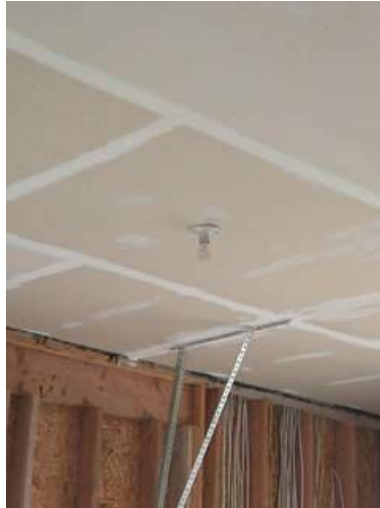
One or more light fixtures were inoperable (didn't turn on when nearby switches were operated). Recommend further evaluation by replacing bulbs and/or consulting with the property owner. If replacing bulbs doesn't work and/or no other switch(es) can be found, then recommend that a qualified electrician evaluate and repair or replace light fixtures as necessary.

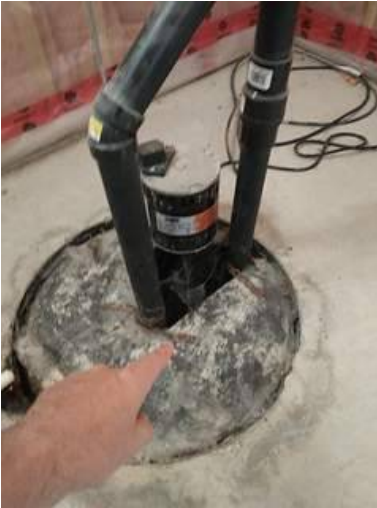
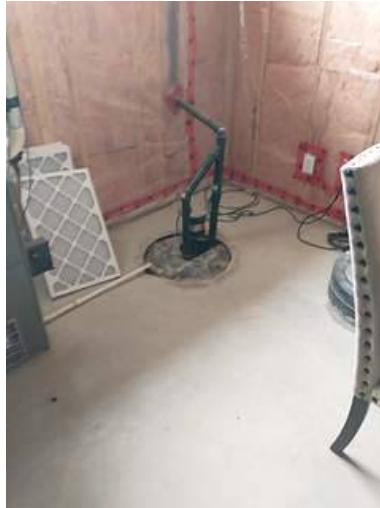
13) **i** A sump pump was installed in the basement. These are specialty systems and only a limited evaluation was performed as part of this inspection. The inspector does not determine the adequacy of sump pumps and their associated drainage systems. The presence of a sump pump may indicate that water routinely accumulates below or inside the structure. Recommend asking the property owner how often the sump pump operates and for how long at different times of the year. The client should be aware that the service life of most sump pumps is 5-7 years, and that the pump may need replacing soon depending on its age and how often it operates.

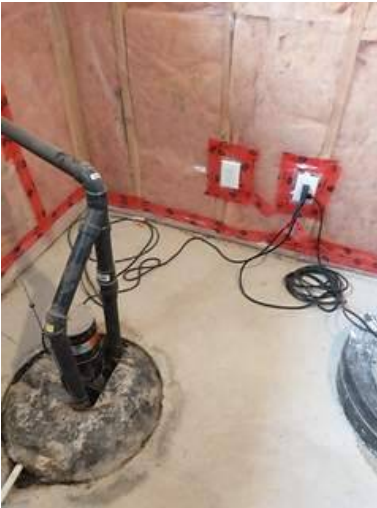
Photo 14-1

14) **i** No battery backup system was found for the sump pump. If the power goes out during heavy rains, the sump pump won't be able to eliminate accumulated water. Consider installing a battery backup system for the sump pump.

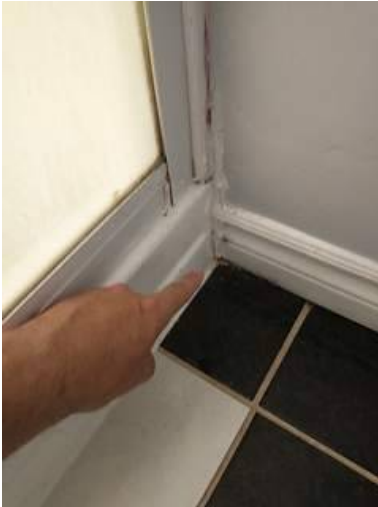
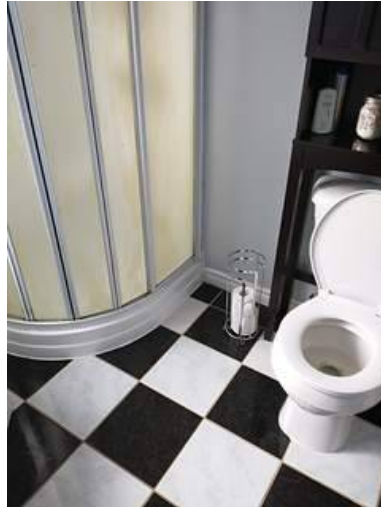
17) 🛠️ The wall by the shower at location(s) #B was water-damaged. Recommend that a qualified person repair as necessary.

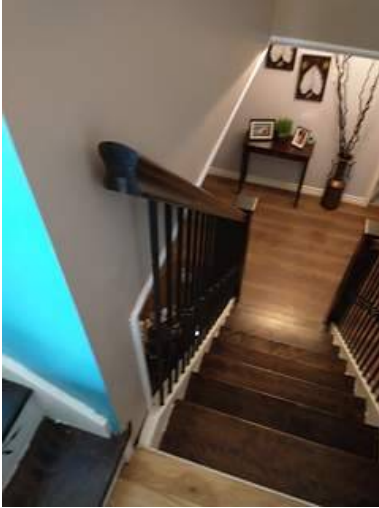
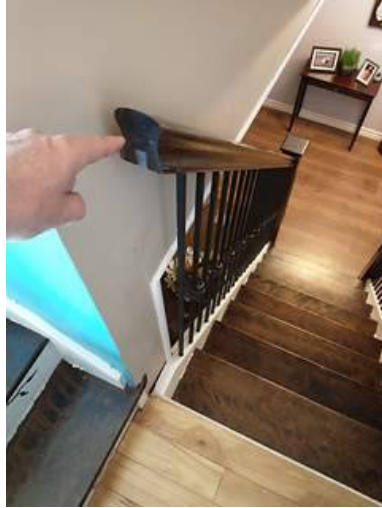
18) 🚧 🛠️ Handrails at one or more flights of stairs were wobbly. This is a safety hazard. Recommend that a qualified person repair as necessary.

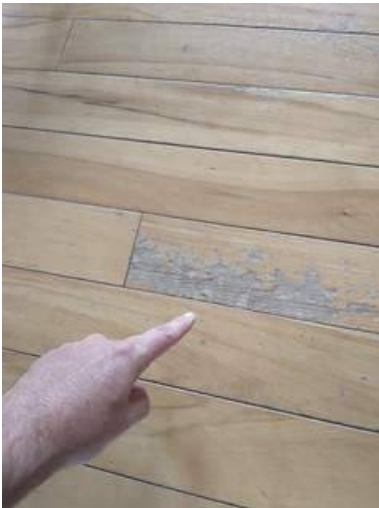
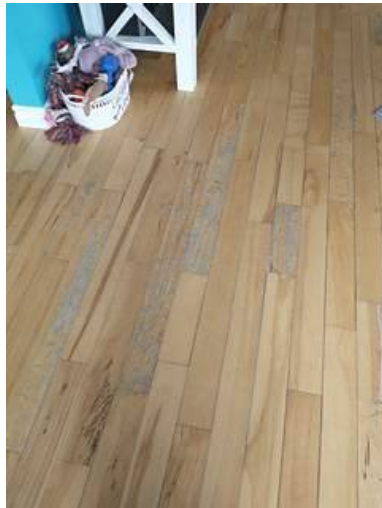
19) 🚧 🛠️ Wood flooring in one or more areas was significantly worn, deteriorated or damaged. Recommend that a qualified contractor refinish wood flooring as necessary.
